SAS Superstructure

Daily Diary Report by Bid Item

Contract No.: 04-0120F4

04-0120F4
04-SF-80-13.2/13.9
Self-Anchored
Suspension Bridge

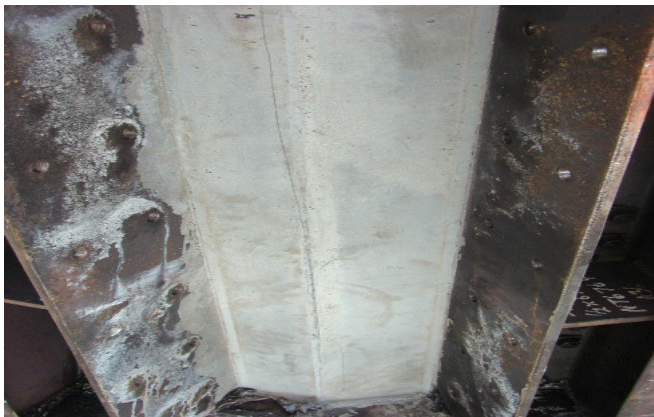
Exposed grout surface at the bottom corner between Panels 2 and 3.

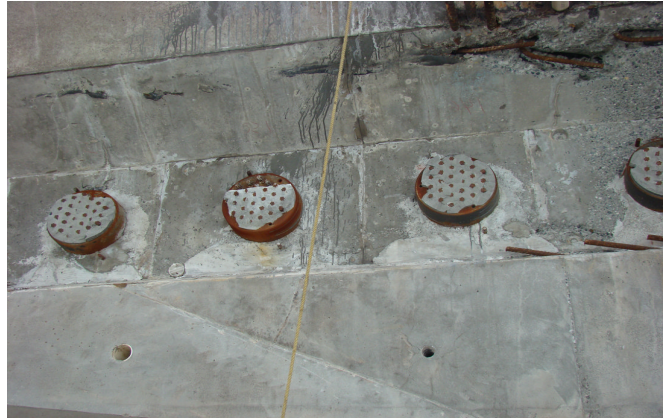
Rust on the anchorheads and wedges of CBT-11 to CBT-15 on the south end of the W2 cap beam.

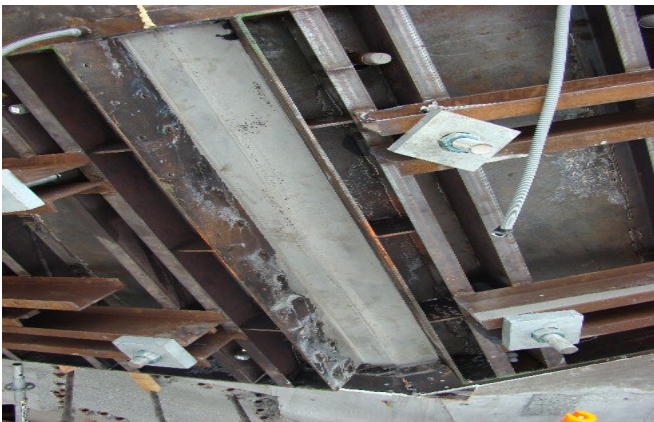
There were a few vertical cracks observed from the top to the bottom.

Exposed grout surface at the corner between Panels 2 and 3.

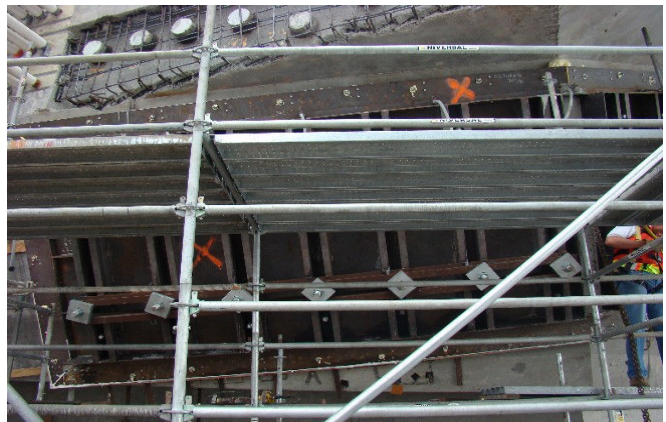
Location on Panel A where ABF was to expose the grout surface undisturbed or prior to form and grout pad removal.

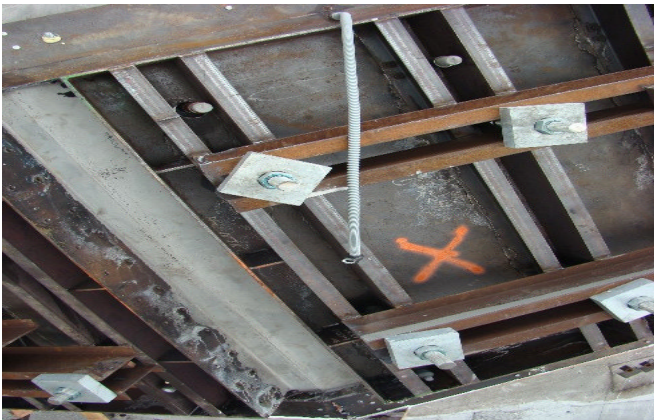
Lower corner on Panel 3 near the Panel 2 and 3 joint to be exposed.

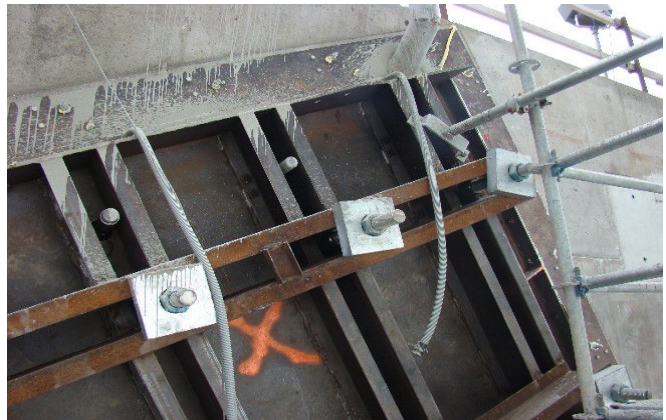
Upper corner on Panel 3 to be exposed.

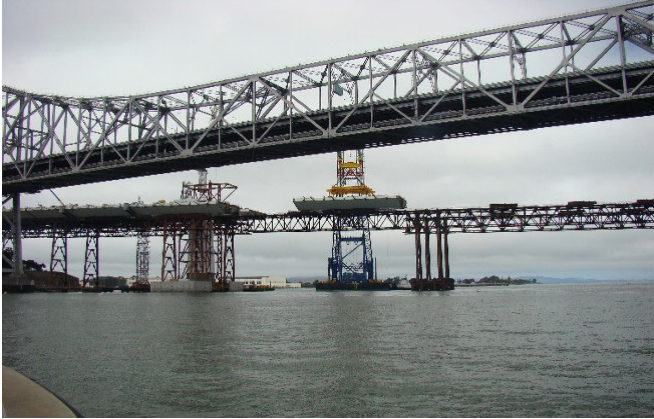
Erection of OBG lift 8E was done today and pushing the lift towards the east commenced.

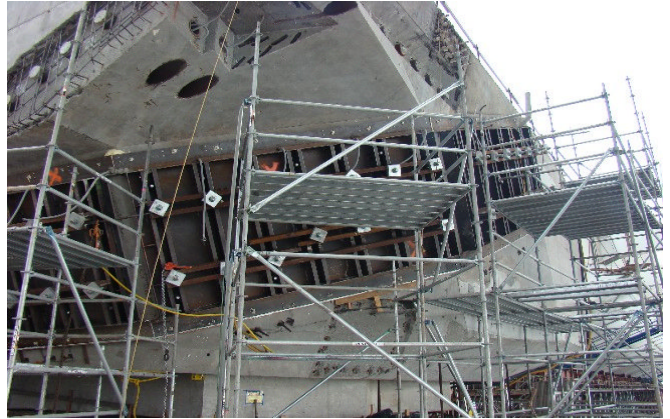
Locations where ABF was to expose the grout surface for undisturbed inspection of the grout pad was marked with a orange X on the forms on Panel B.

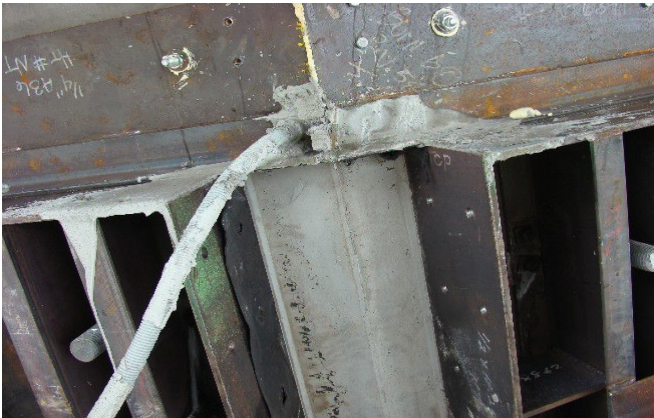
Exposed grout surface at the top of the corner between Panels 1 and 2. There was a vertical crack observed from the top to the bottom.
